TYNDALL AFB BOMB DAMAGE REPAIR FIELD TEST, DOCUMENTATION AND ANALYSIS

Lawrence D. Hokanson, Capt, USAF
Air Force Weapons Laboratory

October 1975

Final Report

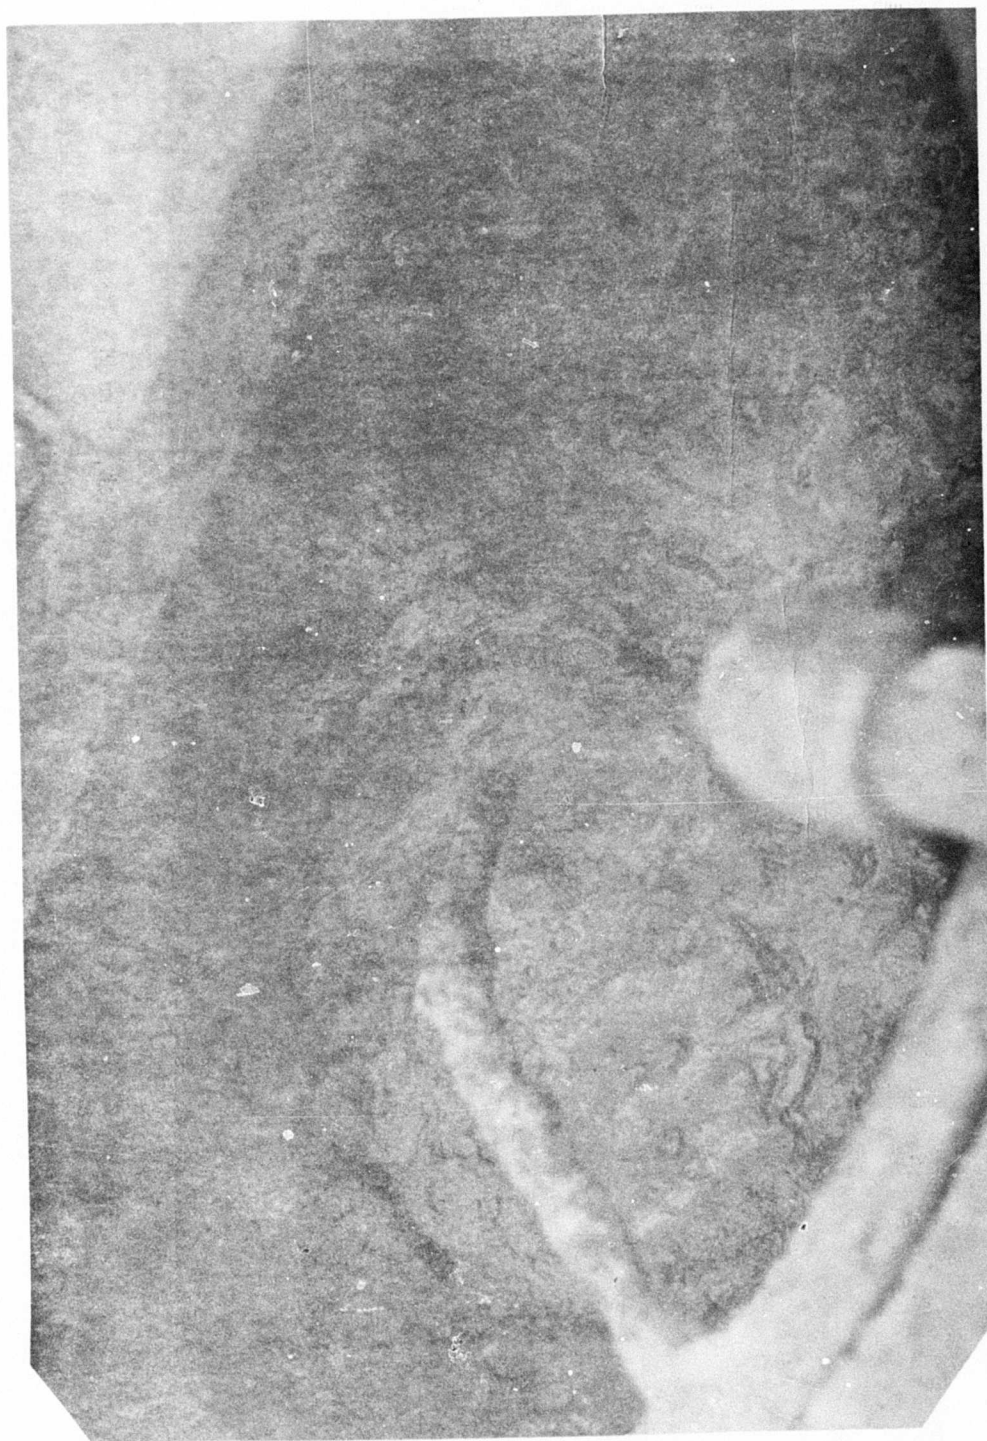
Two concrete slabs, reinforced with welded wire mesh (figure 98) were pumped to test the items listed above. A major problem developed in attempting to hold the retarded reg-set in the forms long enough for it to set up. It was determined that the forms would be indispensable if an acceptable surface were to be put on the reg-set cap. The retardant system seemed to be improved over the method of adding the citric acid crystals by hand as used in the second test. An injector system was used allowing a controllable amount of citric acid solution to be placed in the system if a steady input water pressure were maintained. Problems with the pump equipment and the mechanical supply of reg-set terminated the test, with the reg-set actually setting up in the mixer (figure 99).

Figure 99. Reg-set Slurry Set up in G-2 Mixer Tub

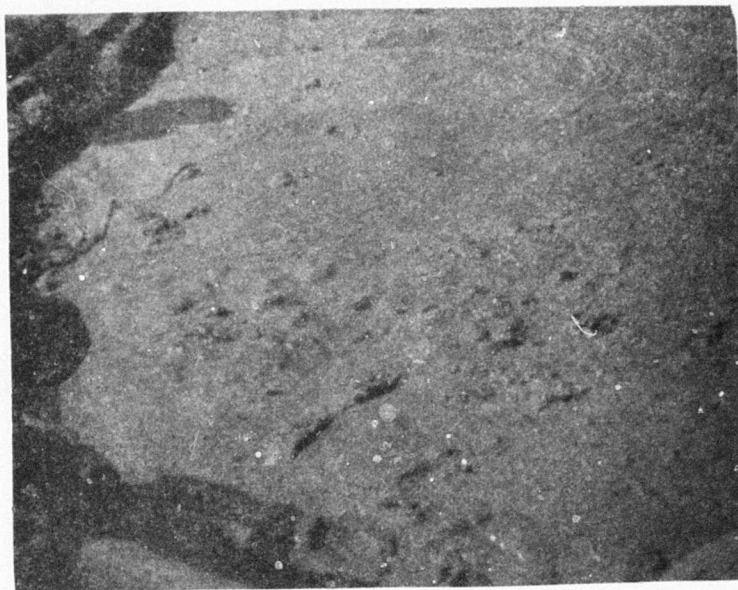
Figure 111. Chunks of Foam Reg-set Floating in Reg-set Slurry Cap, Test 1-4 NW

slurry (figure 111) yielding a possible weakend lower 2 inches of the 12-inch slurry cap. Excavation of the cap, figure 110, showed the failure plane to be very nearly at 45 degrees to vertical, in agreement with Mohr Circle theory defining the plane along which maximum shear occurs. It was noted that the surface temperature of Test 1-4 NW was much higher than the surface temperature of other 1-4 series tests.

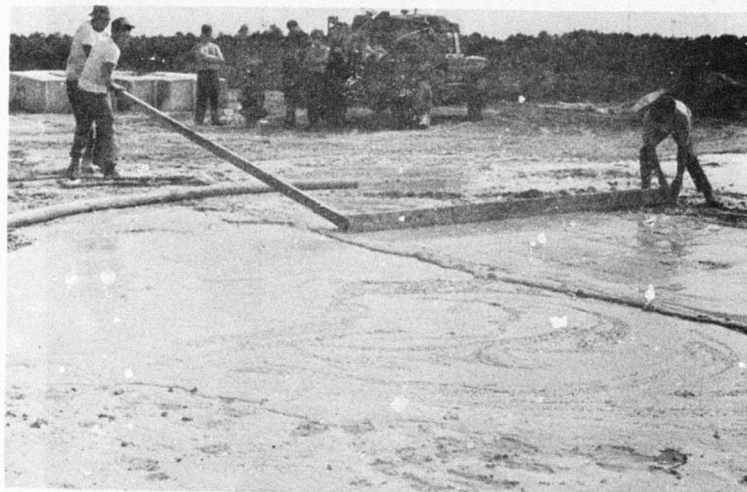
Figure 112. Screeding Reg-set Cap for Test 1-4 NW

Some problems were experienced in screeding this repair (figure 112) and it was realized that a carefully controlled and prefabricated form system would be essential for further work with reg-set.

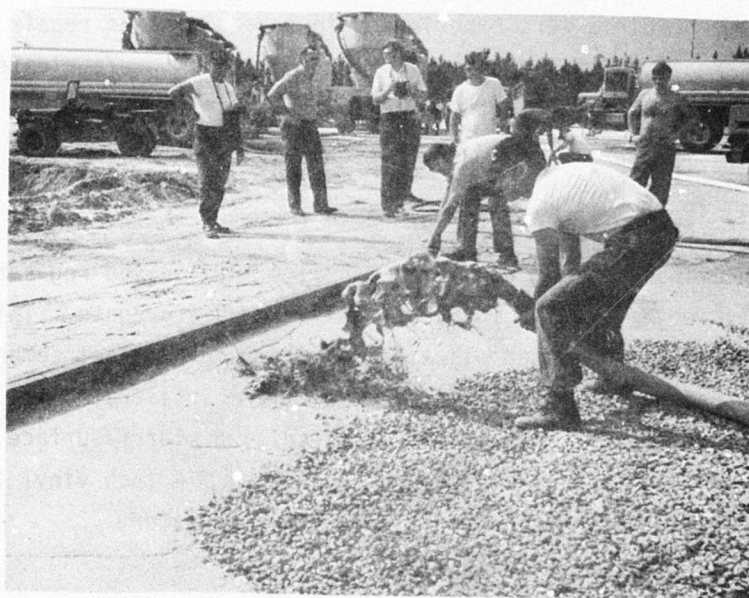
Figure 113. Infiltrating Slurry into Prepositioned Aggregate, Test 1-4 SE

The final reg-set repair in Test 1-4 infiltrated reg-set slurry into a prepositioned $3/4$ to $1\frac{1}{2}$ inch uniformly graded aggregate. This material was thoroughly washed after placement, and a regulated-set cement slurry was flooded on the surface (figure 113). The cement infiltrated the material to the depth of the uniform aggregate. The resulting slurry surface was alternately screeded with a 10-foot board and with a $3/4$ inch vinyl tube (figure 114). The surface was cured by flooding with water.

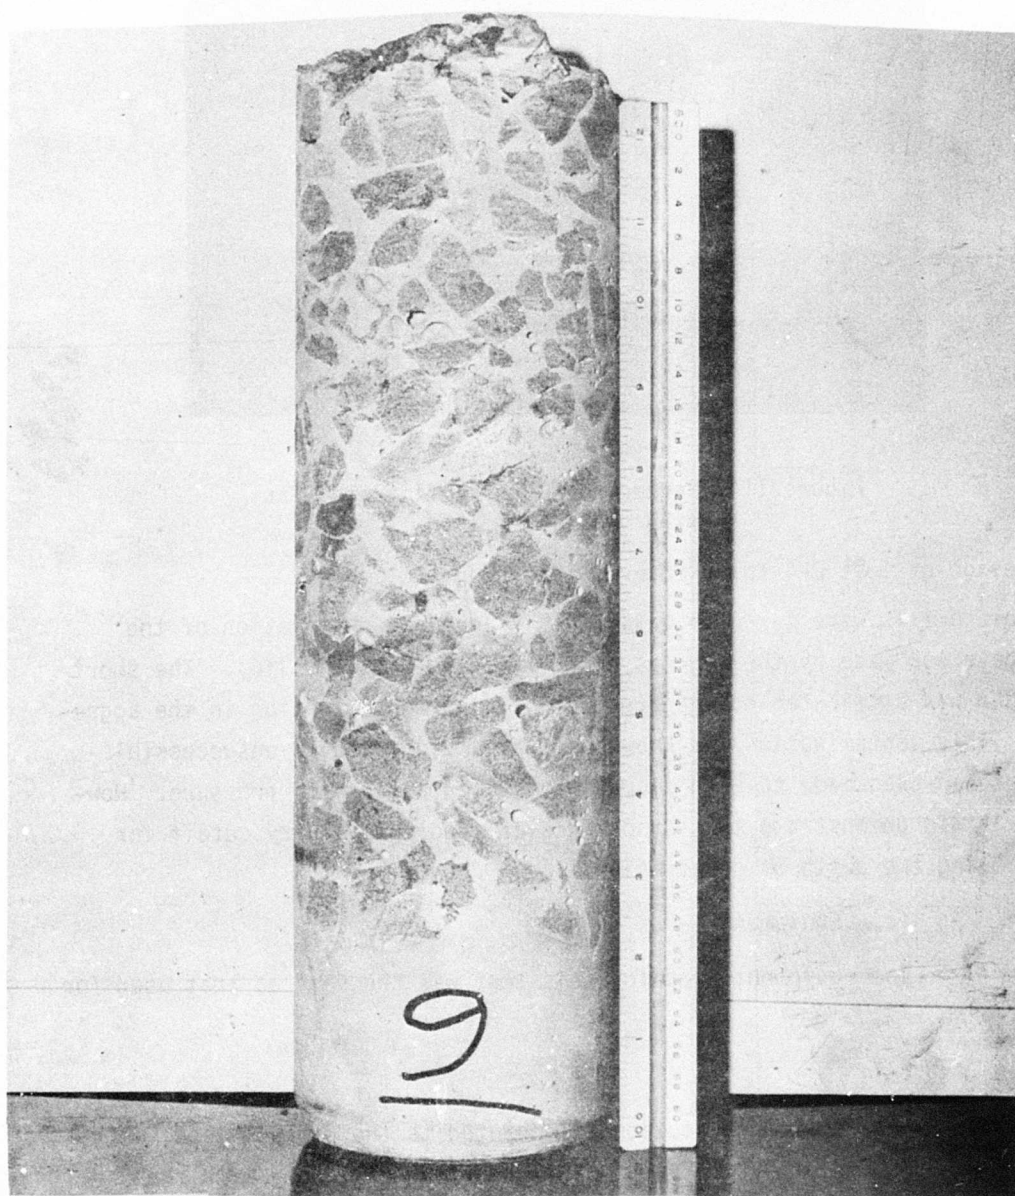
Figure 115. Core Sample of Infiltrated Aggregate Cap, Test 1-4 SE

Core drills were taken to determine if adequate penetration of the aggregate was made by the reg-set slurry (figures 115 and 116). The short cylinder was attributed to the presence of sand contamination in the aggregate. This contamination was known before pumping, and an unsuccessful attempt had been made to wash it out with water under high pressure. However, it did demonstrate that sand makes an excellent slurry cutoff for controlling the depth of penetration.

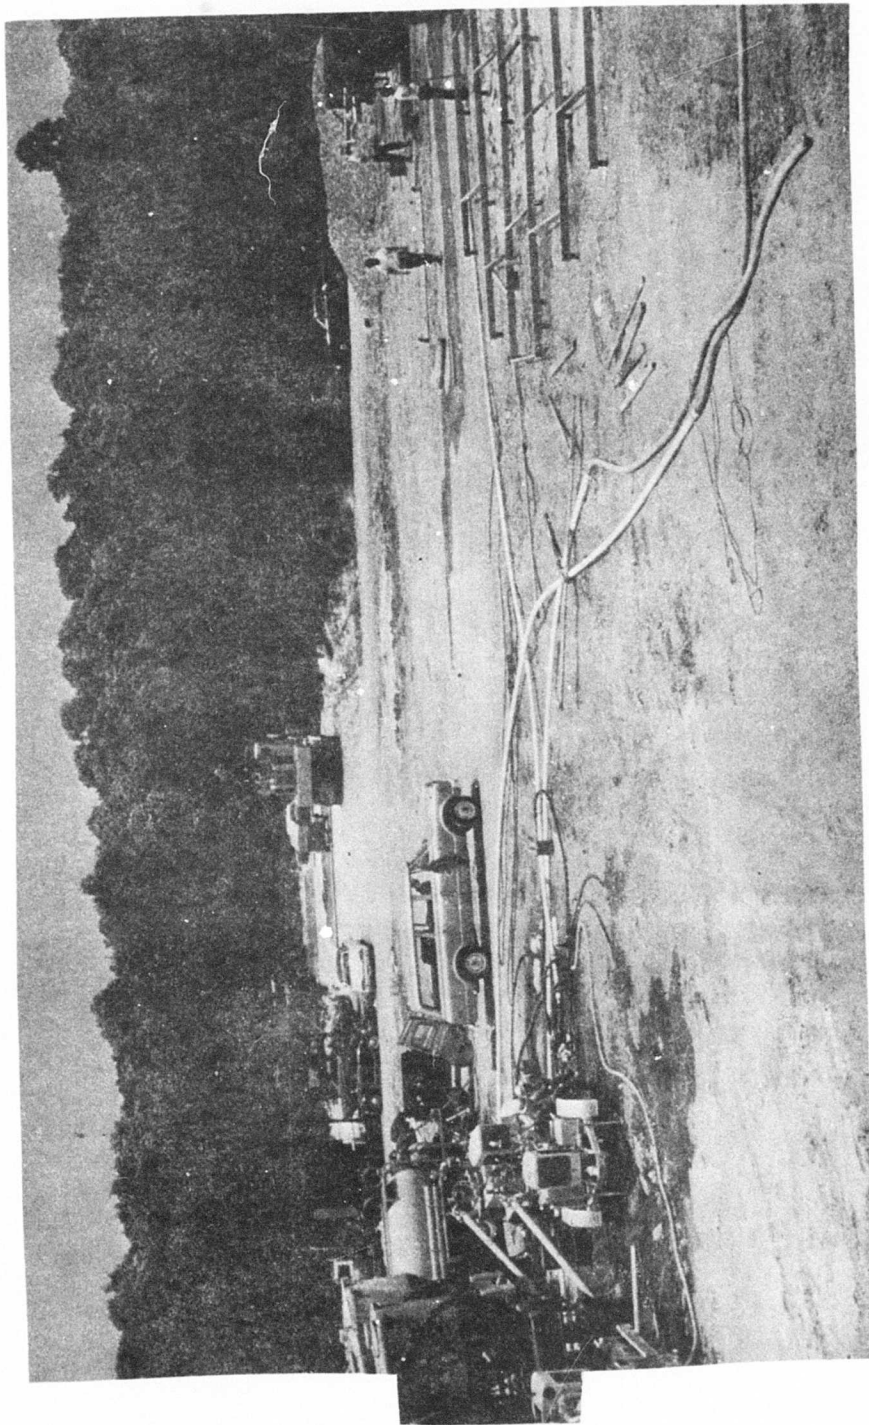
Figure 117. Lengthy Supply Lines for Test 2-1

Although three pumps were available, only the two more advanced G-3 pumps on lease were actually used. These pumps ran without incident and were often switched from foam to slurry as the requirements dictated. As seen in table 20, section VII, the pumping of the crater backfill took some 2 hours and 46 minutes to complete, with the pumps running about 2 hours and 29 minutes of this time. The volume of reg-set used in foam and slurry cannot be accurately determined, and so an accurate delivery rate cannot be calculated. However, the maximum pumping rate was not used because of the resultant velocity of the material leaving the hose nozzle and consequent thrust produced. The velocity in the 3-inch hose would be 7.45 FPS, an exceptionally high speed for slurry placement. The actual pump time for the cap was 1 hour and 8 minutes on one pump and 51 minutes on the other. Thus, the whole project took a total of 6 hours and 57 minutes of pump time. If the volume is assumed to be 175 CY of slurry at a density of 110 PCF and 100 CY of foam at a den of 50 PCF, or a total of 275 yards pumped, the pump performance is about 40 CY per hour. A larger hose could have improved this performance but would have caused larger problems in the lengthy supply lines (figure 117) due to reduced velocity and possible premature set-up in the lines.

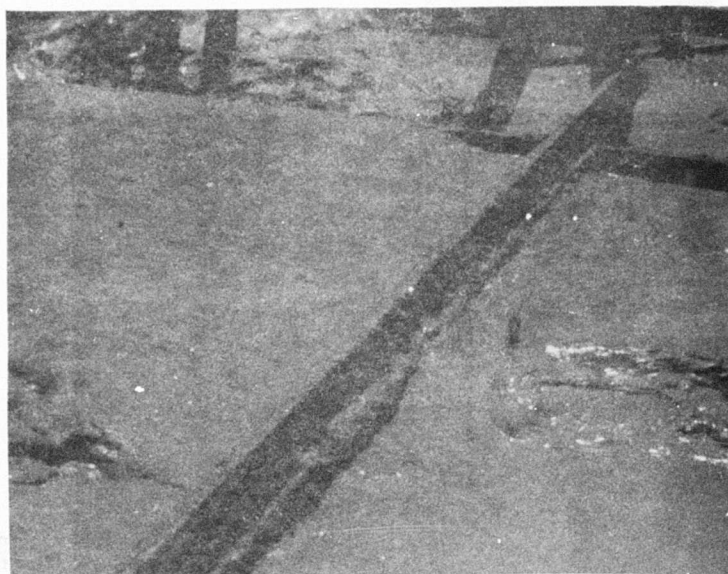
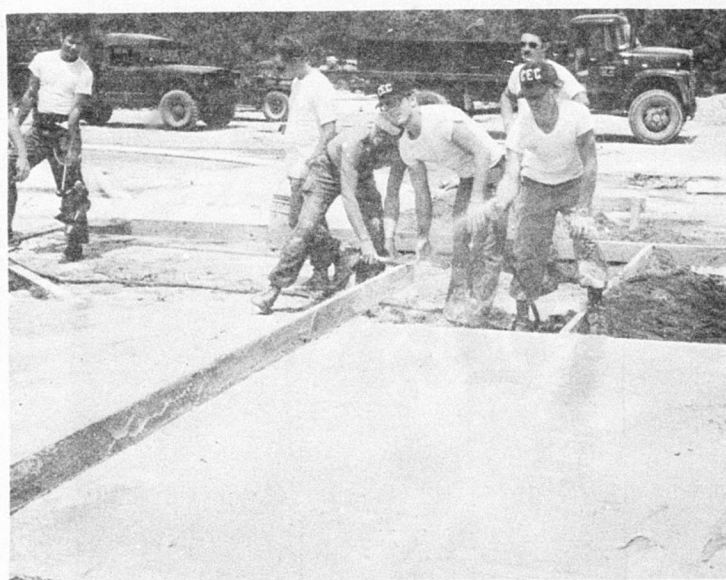
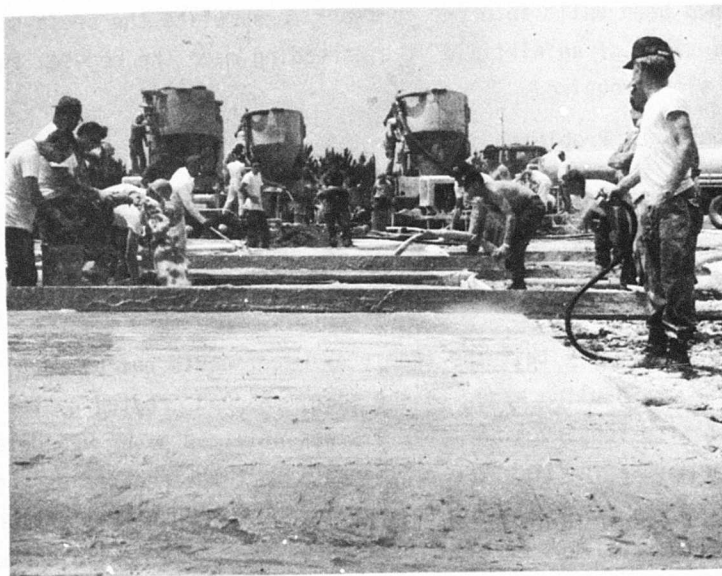
Screeding went exceptionally well, even though the set up time of the reg-set varied due to the temperature factors mentioned earlier in this section. Figures 118, 119 and 120 show the screeding process. The most serious problems seemed to be the exceptionally fatiguing work involved in both hose handling and screeding and the failure of the polyethylene form lining to retain the reg-set slurry until initial set (figure 121). No serious screeding problems arose until the citric acid content was decreased, and a more rapid set time caught the screed crews off guard. In general,

Figure 118. Initial Screeding of Reg-set Cap, Test 2-1

Figure 119. Screed Team Working Center Lane, Test 2-1

Figure 120. Final Screed Surface, Test 2-1, with Mobile Bins in the Background

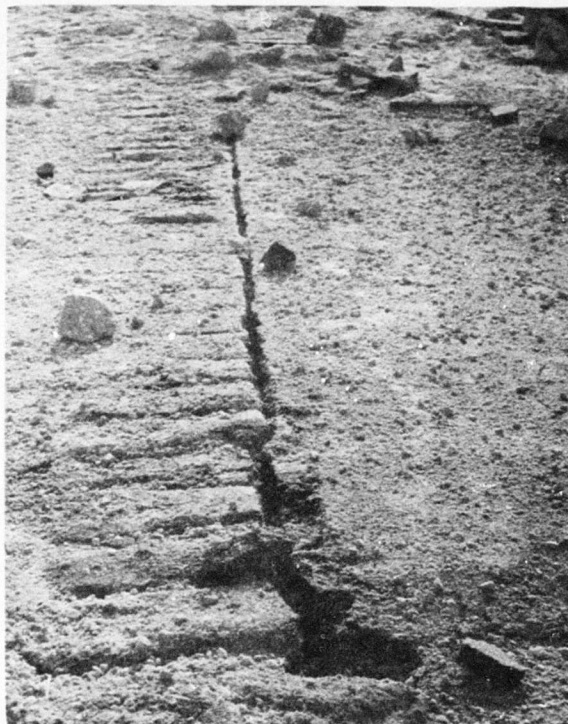
Figure 125. Pavement Cracking Outside Zone of Upheaval, Test 1-2

In addition to the crater and upheaved pavement, severe horizontal stresses created large cracks in the pavement at points far beyond the limit of upheaval. These cracks are shown in the plan view drawings of the damage in appendixes III to VII. Figures 125 and 126 show the type of damage incurred. The pavement between the crater and the runway edge was pushed sideways due to a lack of support along the runway edge. In one case, the displacement between two adjacent pavement sections at the runway edge was 6 inches.
